Landusky Mine Reclamation Progress

- **Reclamation Includes:**
 - Backfilling
 - Regrading/Lime Amendment
 - Barrier Placement
 - Soil Placement
 - Revegetation
 - Maintenance
- **Some Reclamation done by ZMI prior to 1998**
- **Interim Reclamation began in 1999 by DEQ and BLM after site abandonment by ZMI**
- **Over \$ 7 Million in additional reclamation funds provided by BLM and DEQ**

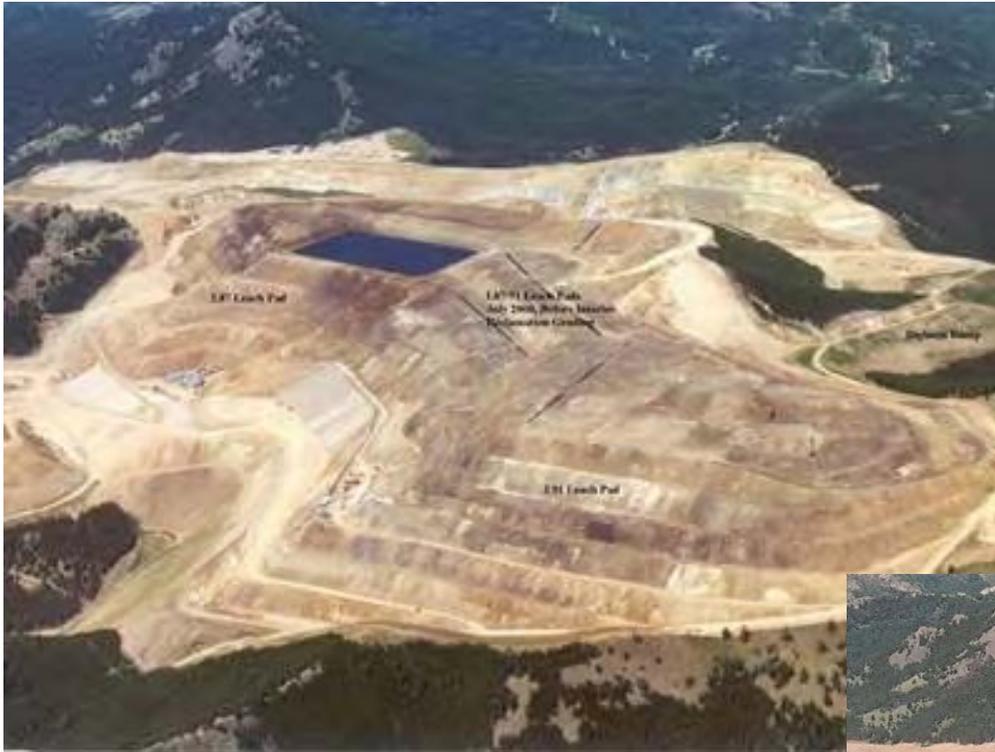
**July 2000 - L87/91 Valley-Fill Leach Pads.
Contains 112 million tons of spent ore, over
150 million gallons of residual cyanide
solution and covers over 200 acres.**

**July 2005 - L87/91 Leach Pad After
regrading, topsoil placement and
seeding. Second year vegetation.**

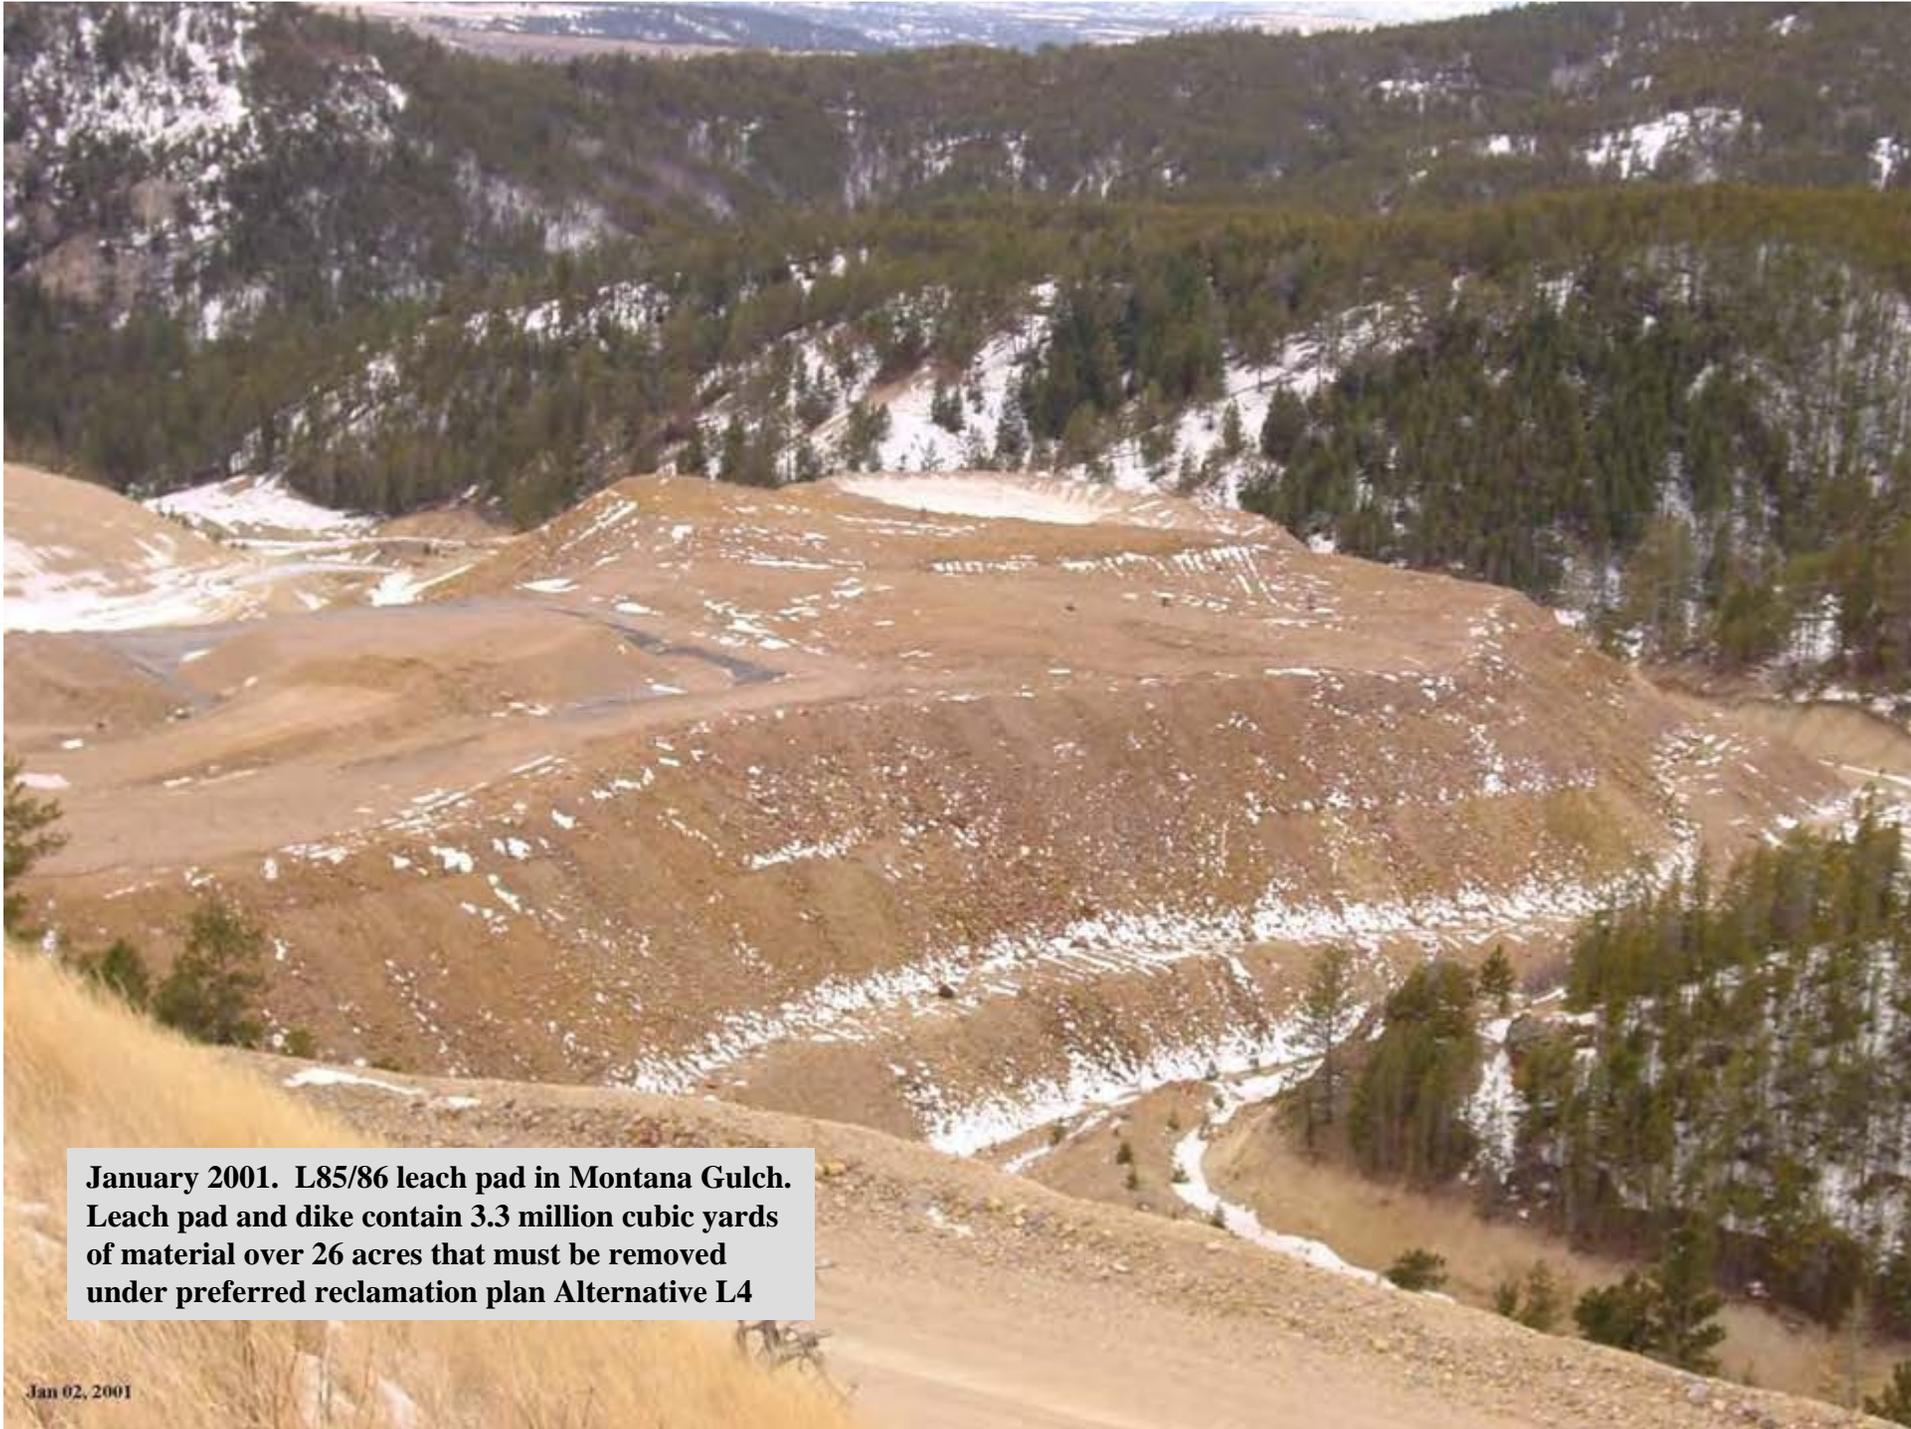
January 2001. L85/86 leach pad in Montana Gulch. Leach pad and dike contain 3.3 million cubic yards of material over 26 acres that must be removed under preferred reclamation plan Alternative L4

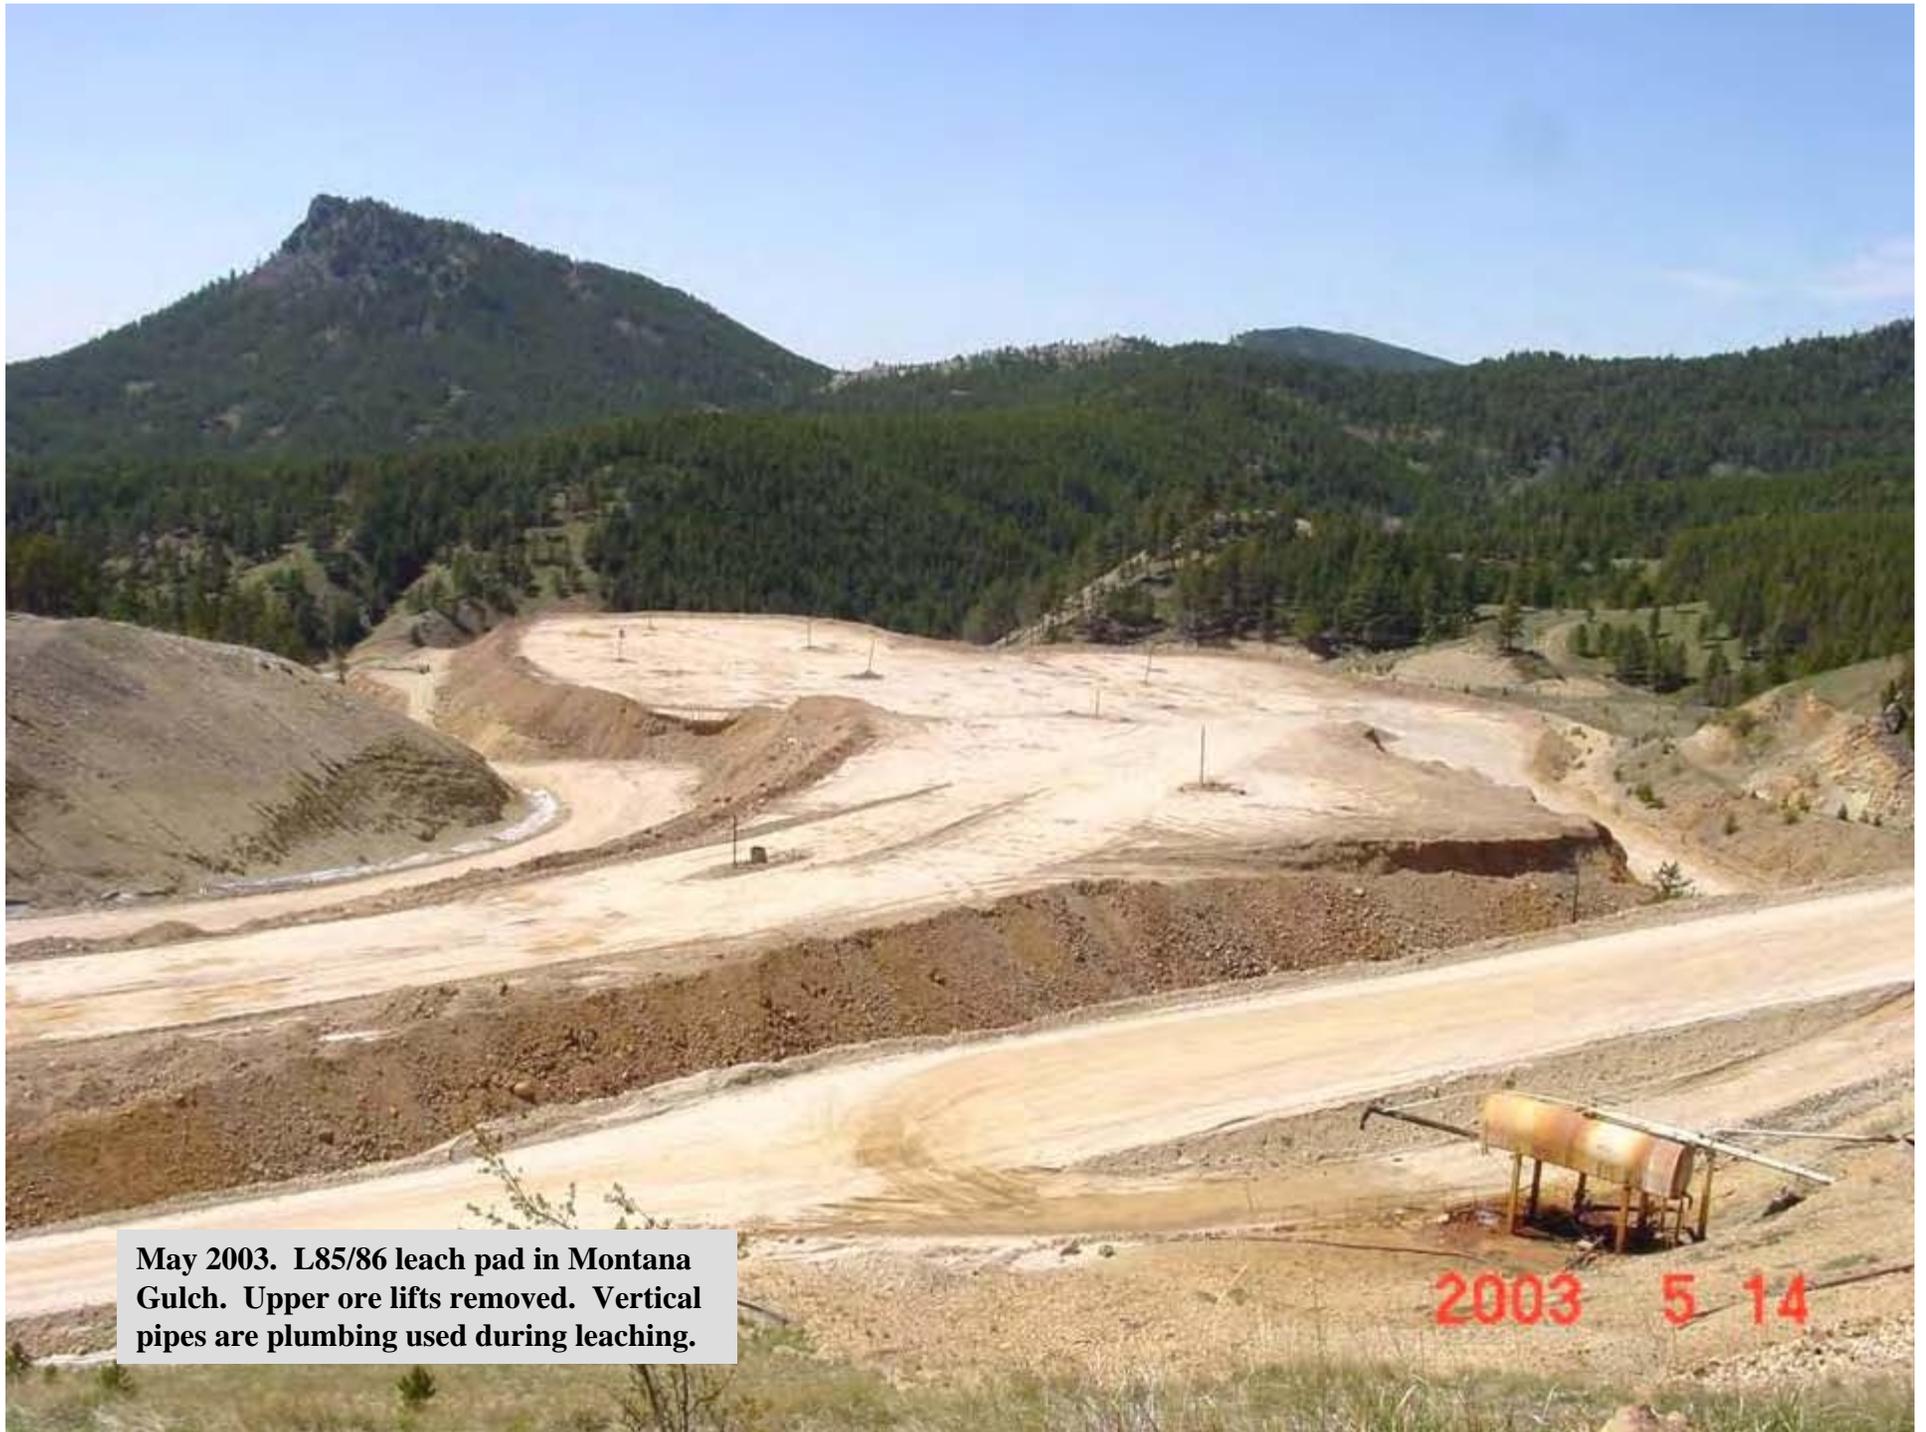
May 2003. L85/86 leach pad in Montana Gulch. Upper ore lifts removed. Vertical pipes are plumbing used during leaching.

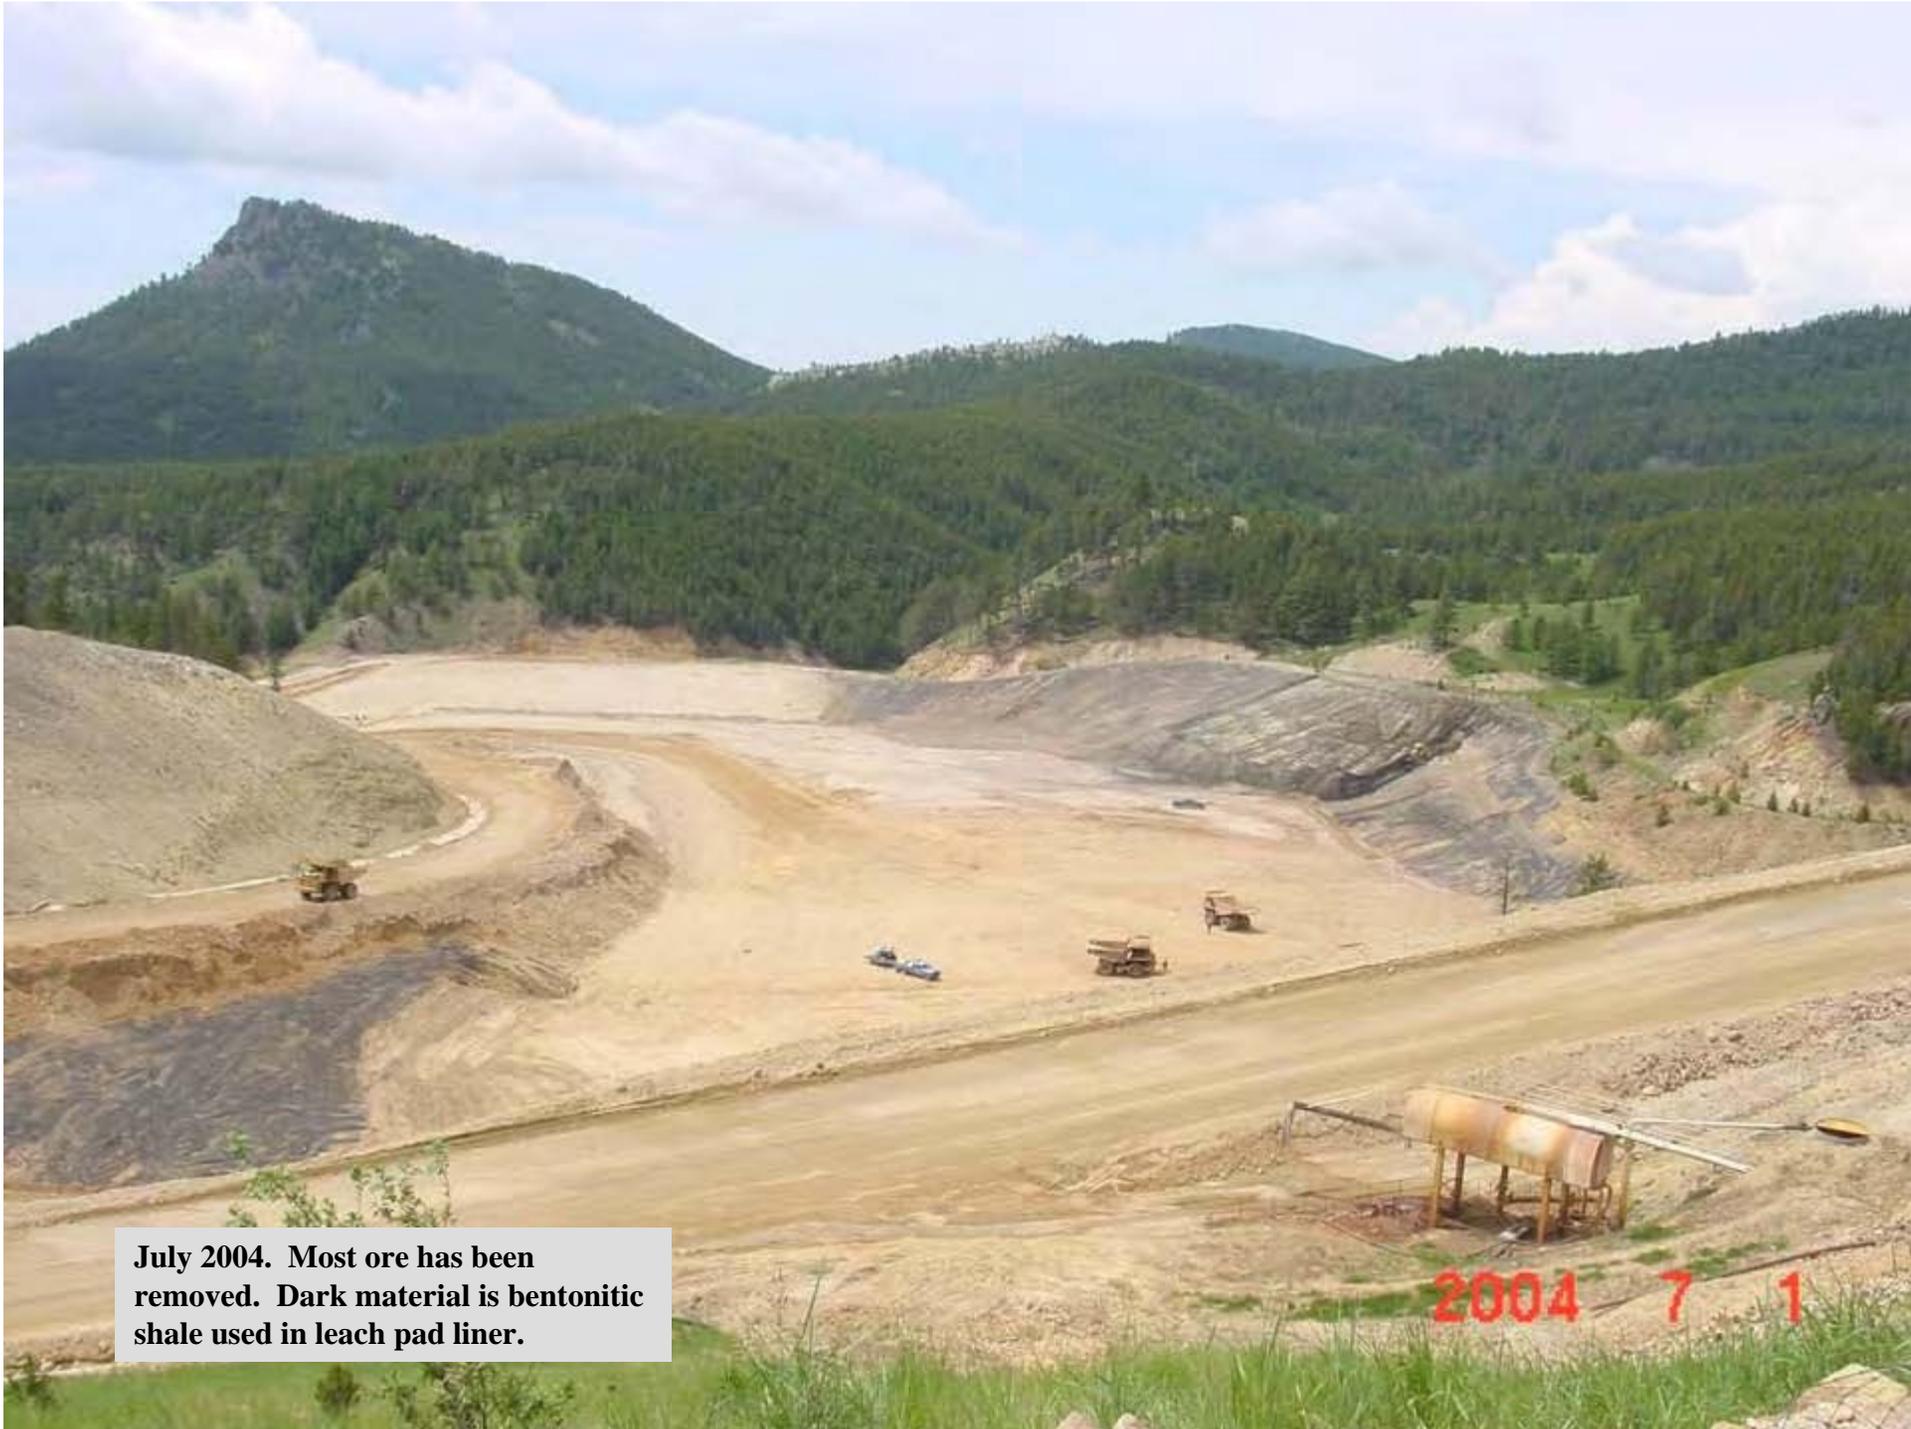
July 2004. Most ore has been removed. Dark material is bentonitic shale used in leach pad liner.

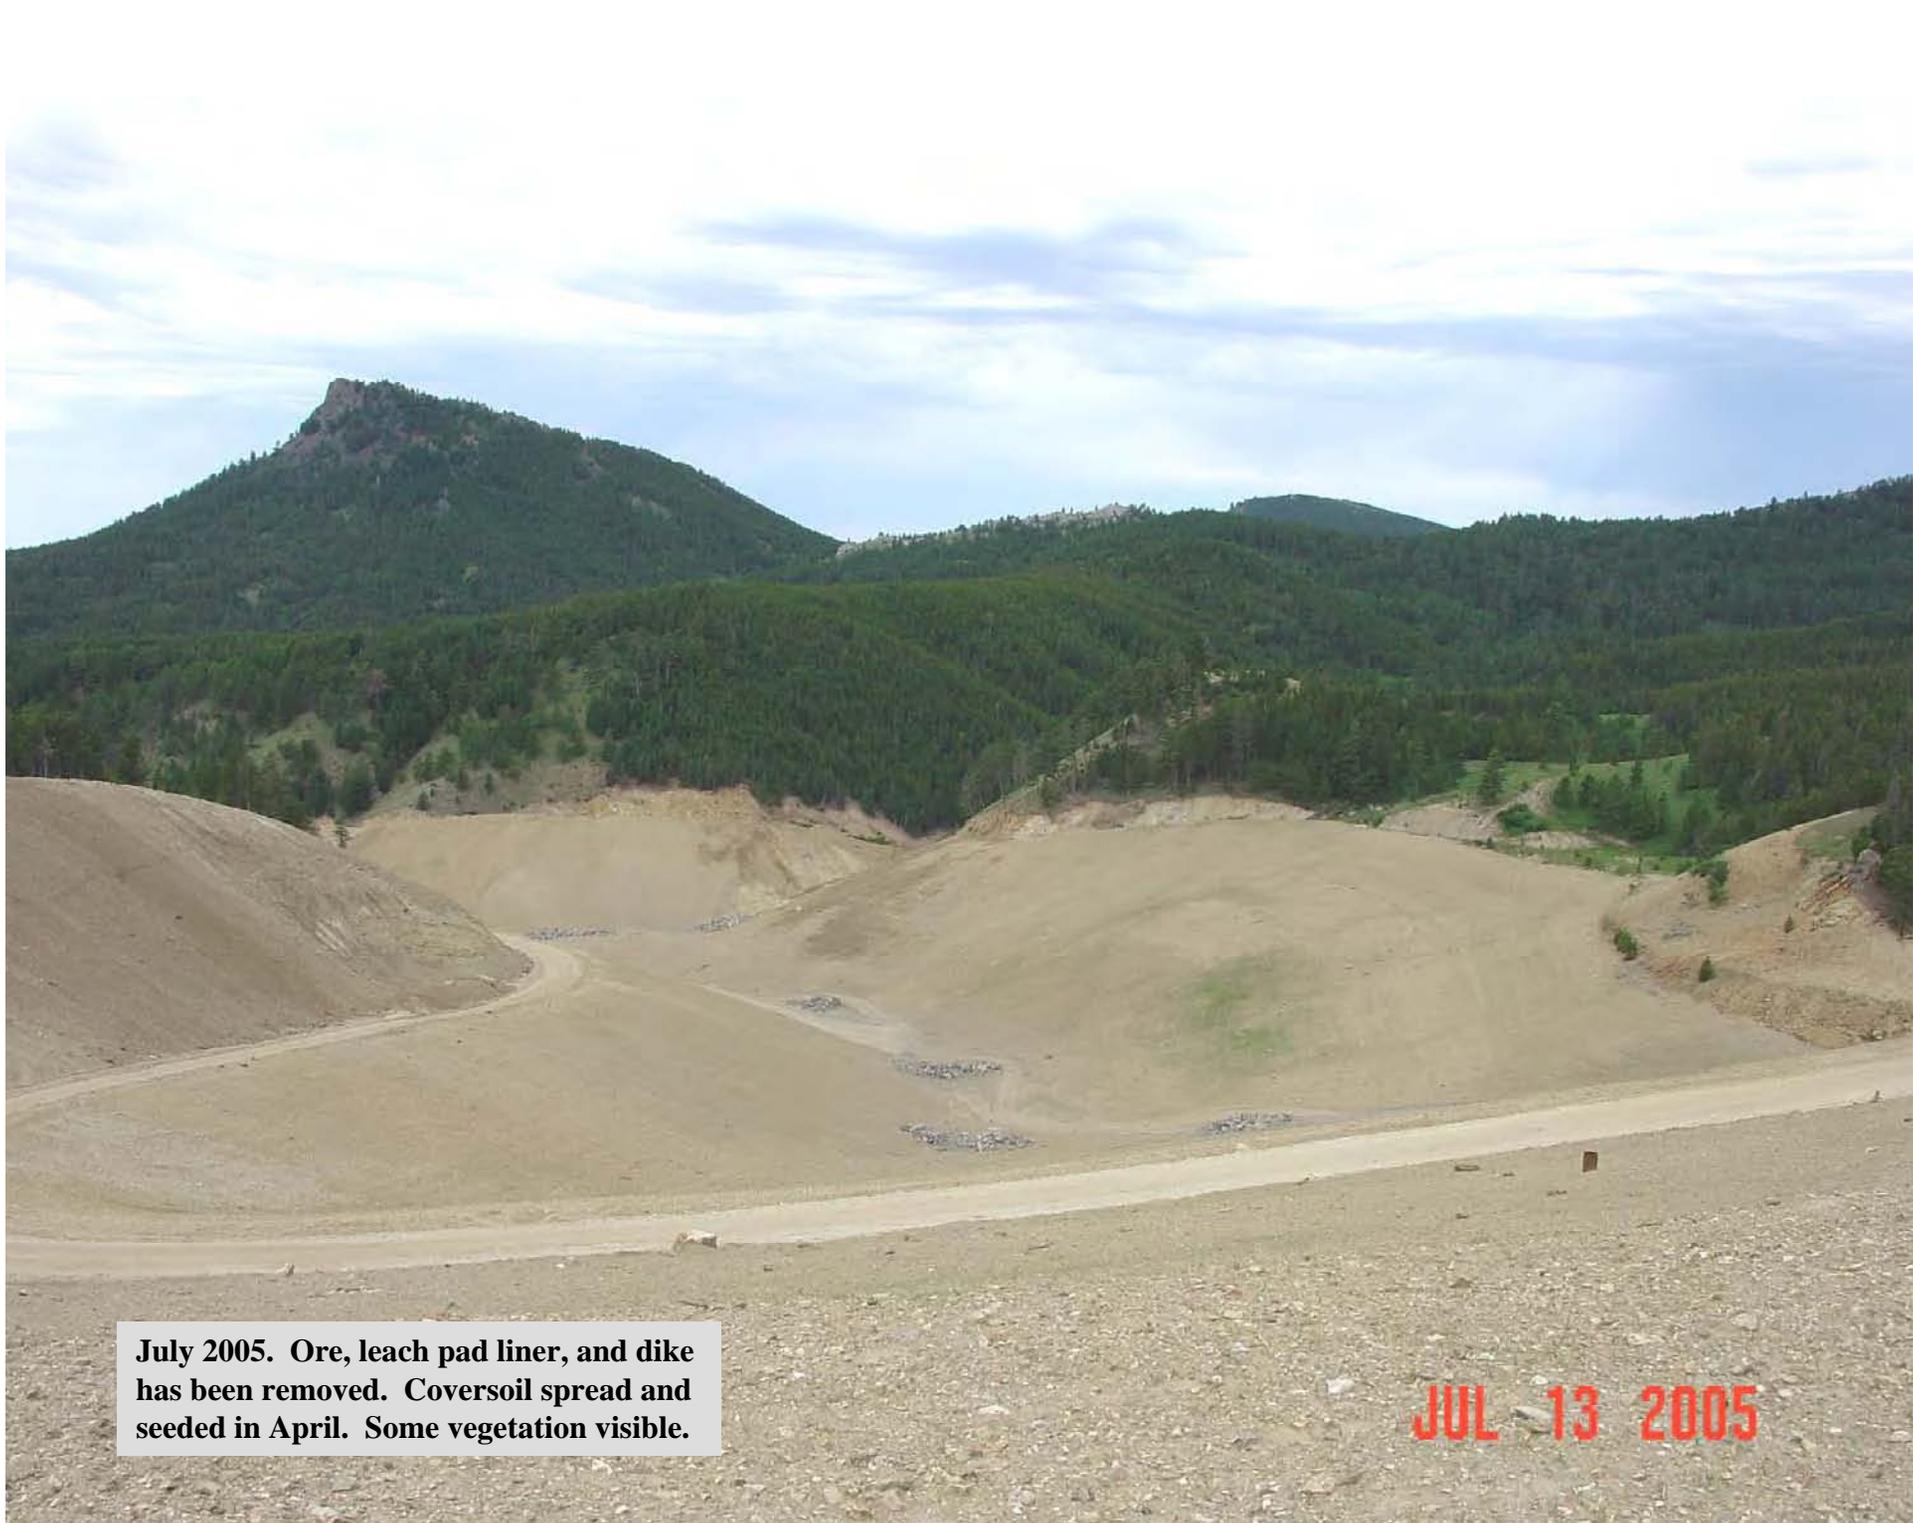
July 2005. Ore, leach pad liner, and dike has been removed. Coversoil spread and seeded in April. Some vegetation visible.

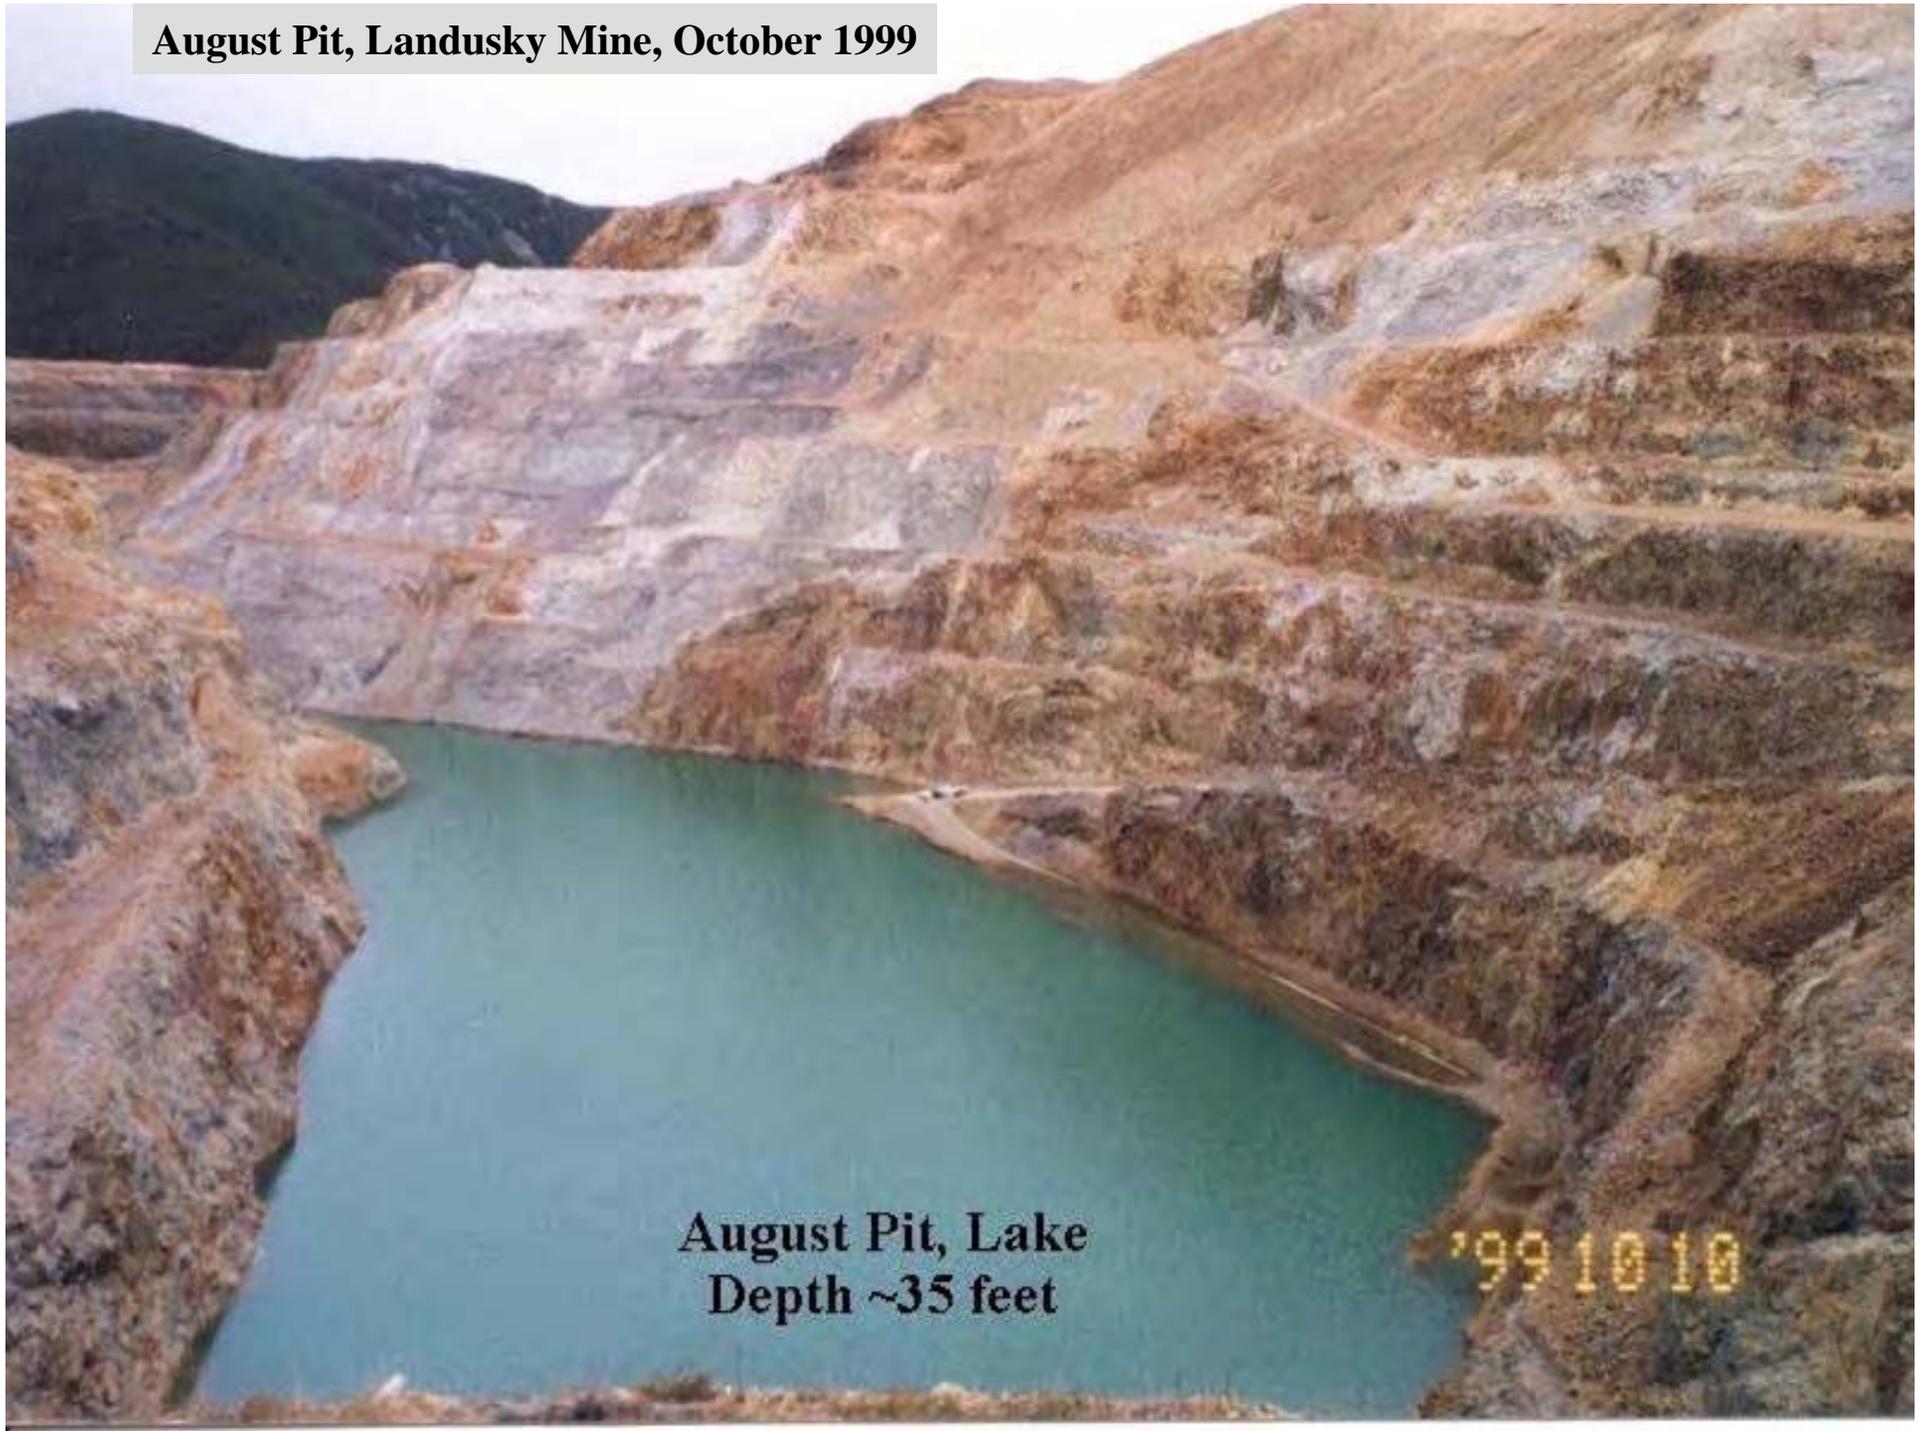
**August Pit, Lake
Depth ~35 feet**

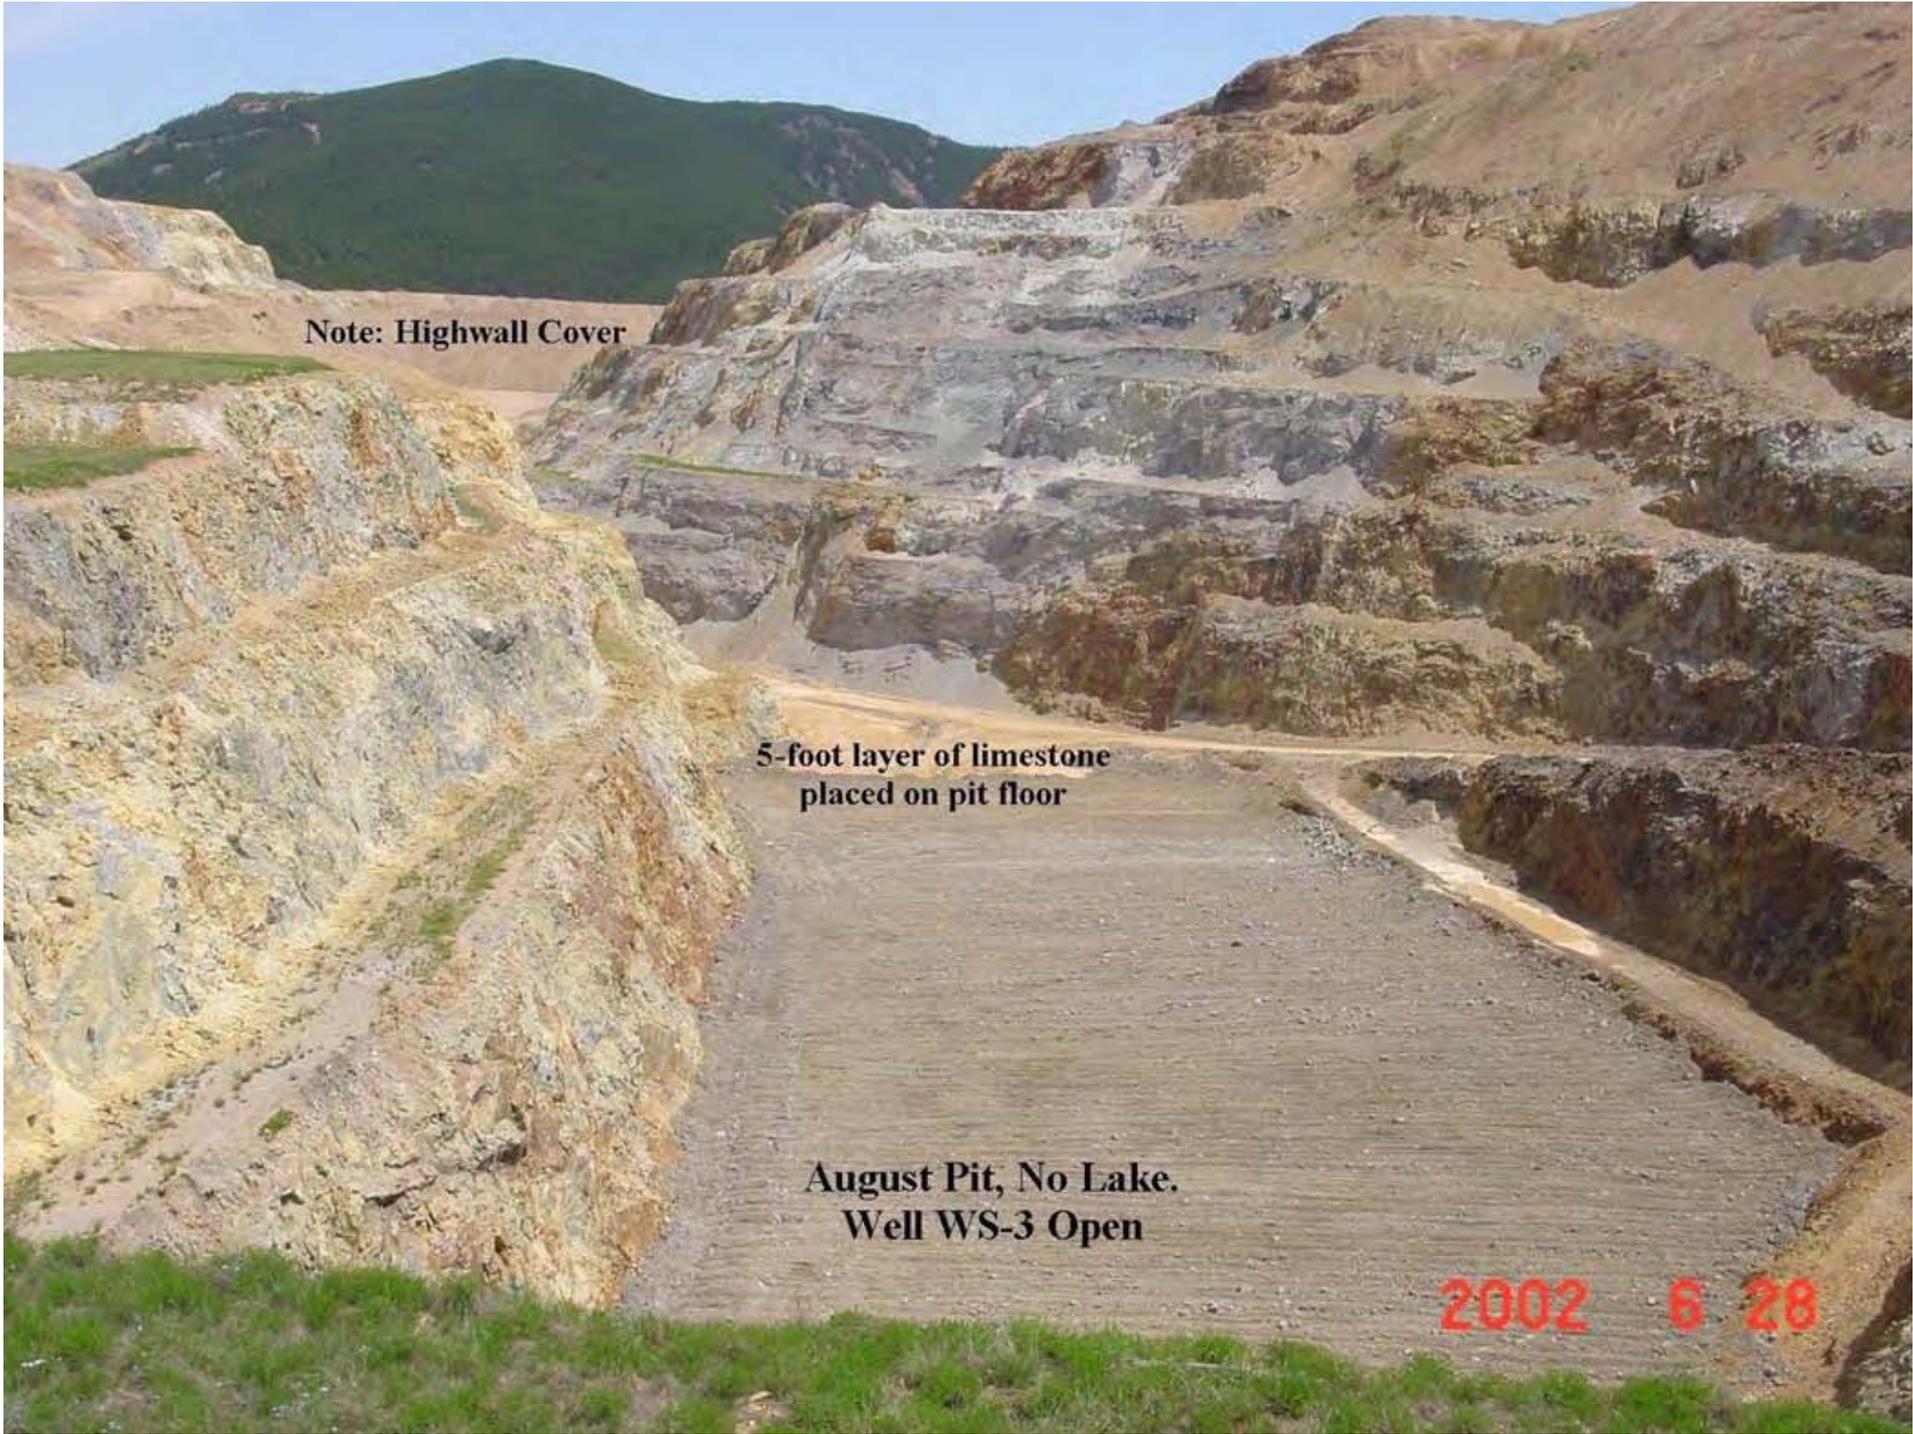
Note: Highwall Cover

**5-foot layer of limestone
placed on pit floor**

**August Pit, No Lake.
Well WS-3 Open**

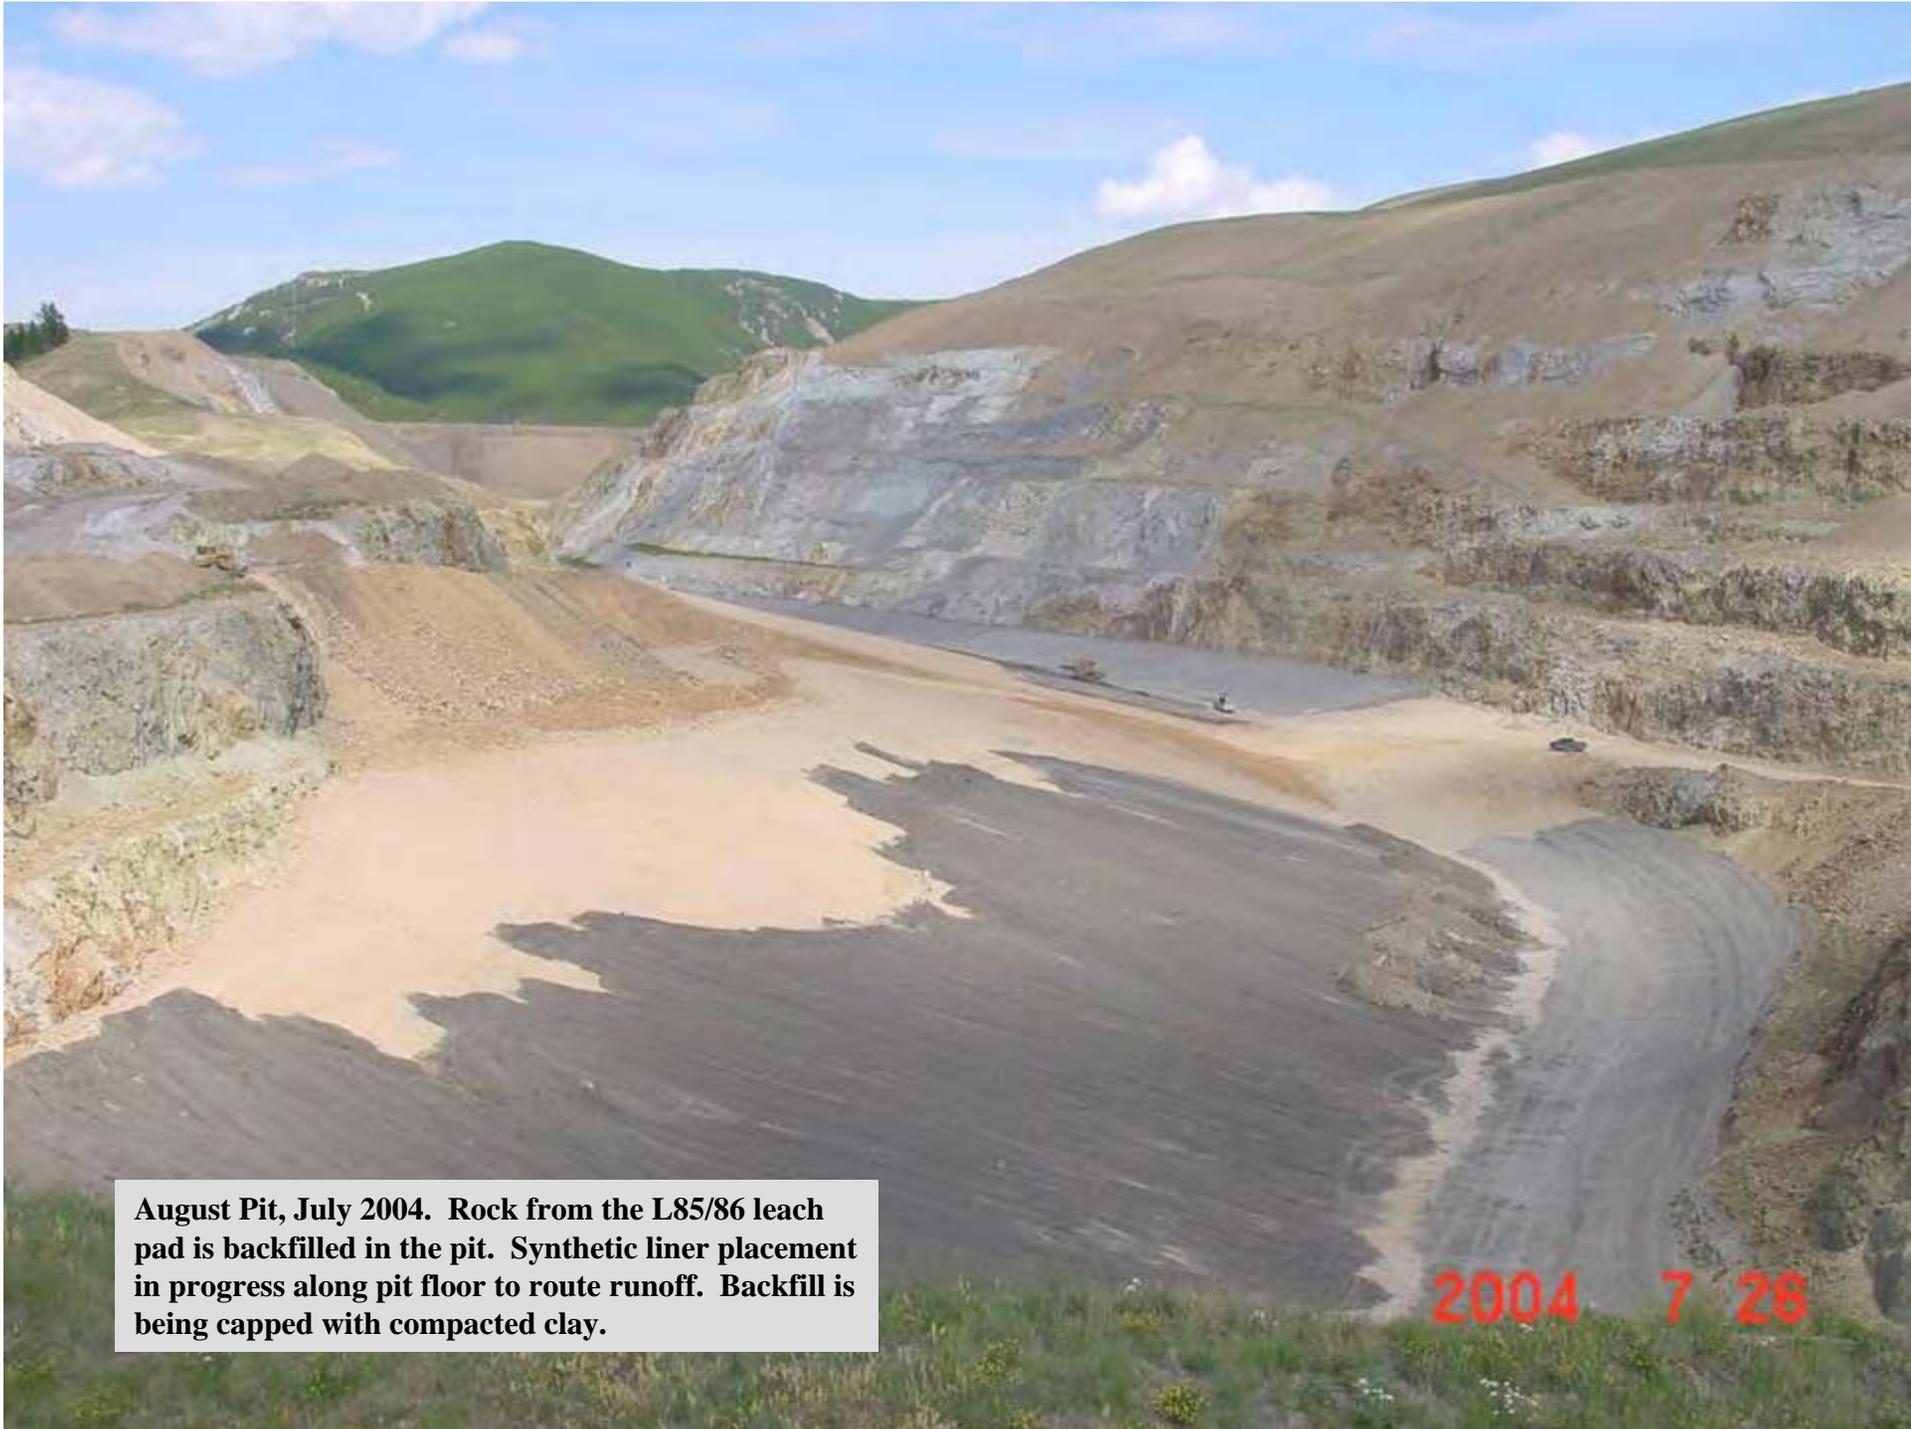
August Pit, July 2004. Rock from the L85/86 leach pad is backfilled in the pit. Synthetic liner placement in progress along pit floor to route runoff. Backfill is being capped with compacted clay.

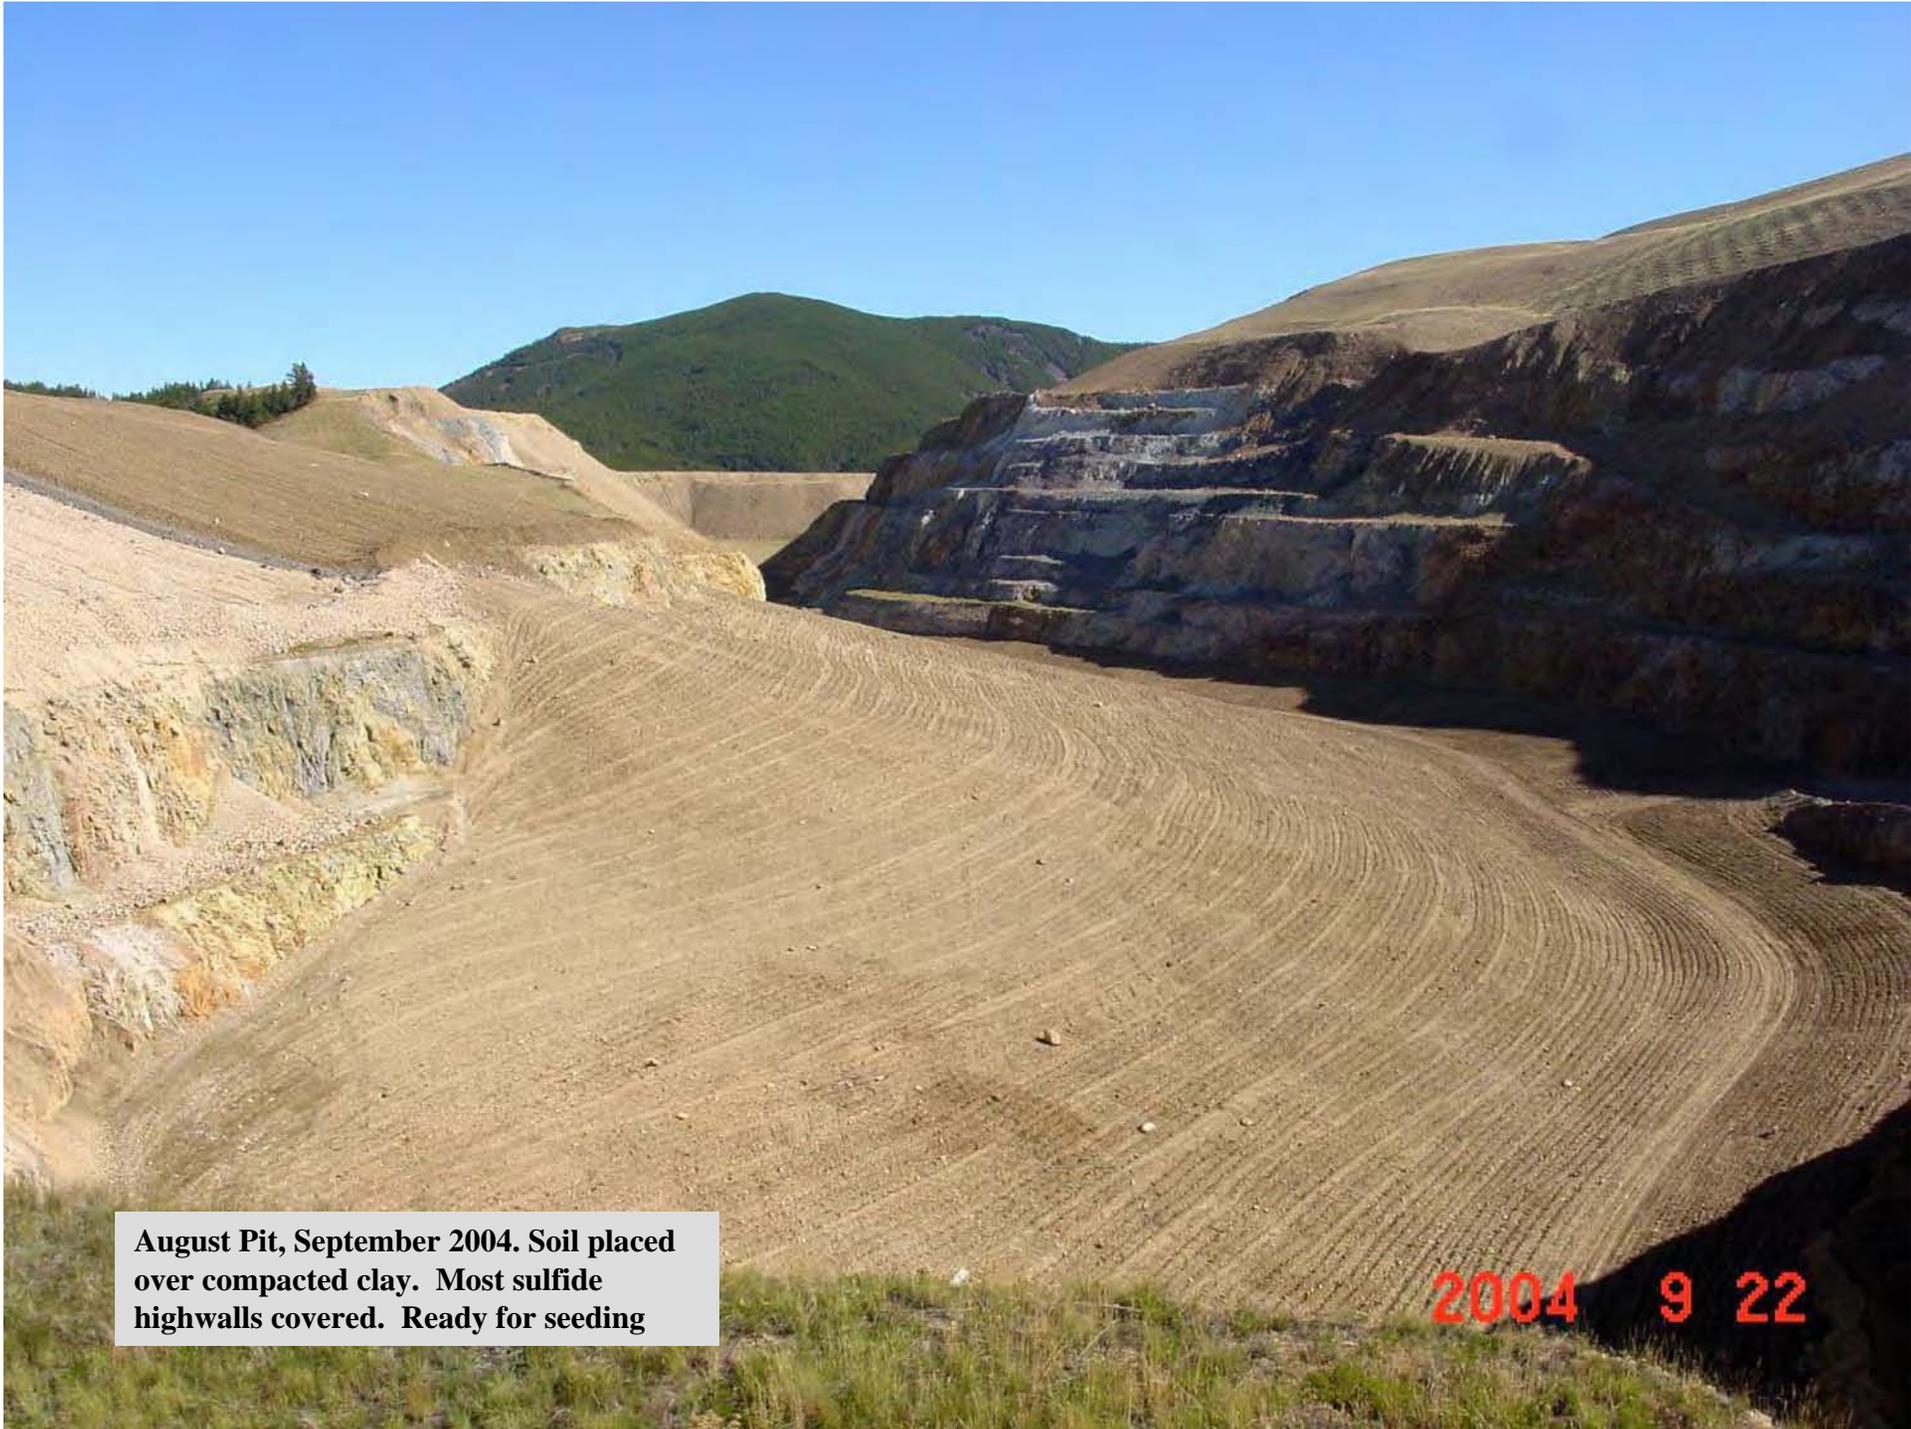
August Pit, September 2004. Soil placed over compacted clay. Most sulfide highwalls covered. Ready for seeding
